A Study on the Coastal Protection System Against Erosion of Bay of Bengal in North Chennai Coast, Tamil Nadu

P. Srinivas* and A. Sreenivasulu

Deptt. of Civil Engineering, K. L. College of Engineering, Vaddeswaram-522 502, A.P., India

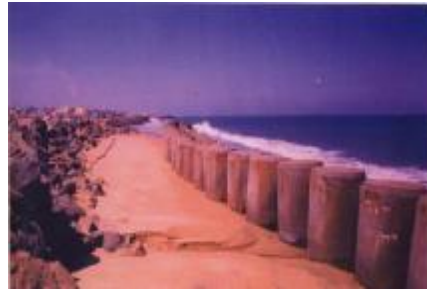
Fig.1: Picture showing the sea wall construction.

The construction of sea wall, the armour layer of the sea wall and the sea erosion remedy wall are shown in Figs. 1, 2 and 3.

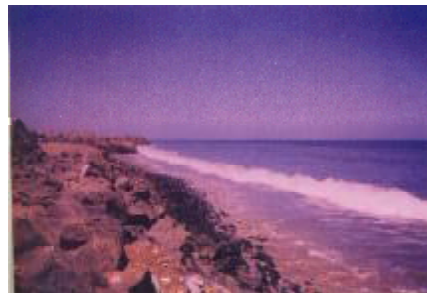
Fig. 2: Picture showing the armour layer of the sea wall.

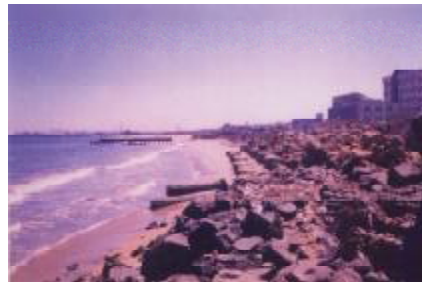
Fig. 3: Picture showing sea erosion remedy wall.

The study with the available data indicates that the area had undergone severe erosion and unless it is stopped, it will affect the industrial belt of north Chennai. Hence, the system of remedial measures by using rubble mound sea wall is suggested.
