## **SPATIAL ANALYSIS OF GROUNDWATER QUALITY IN THE TSUNAMI AFFECTED COASTAL AREAS OF TAMILNADU, INDIA**

**N. Ravisankar and S. Poongothai**

Department of Civil Engineering, Annamalai University, Annamalainagar-608 002, T. N., India

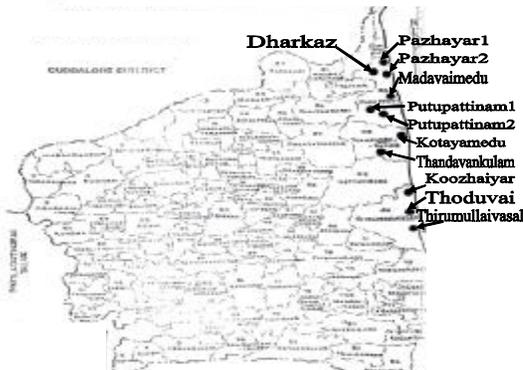
Fig. 1: Study area with sample locations (after tsunami).

The study area is the Sirkazhi taluk coastal region, which is part of Nagapattinam district, situated in the south of Tamilnadu State, India. It lies between latitudes of N 11°6' and N 11°27' and longitudes between E 79°36' and E 79°54'. It is located in the east coastal region of Bay of Bengal. Figs. 1 and 2 show the study area with sample locations after tsunami and before tsunami respectively.

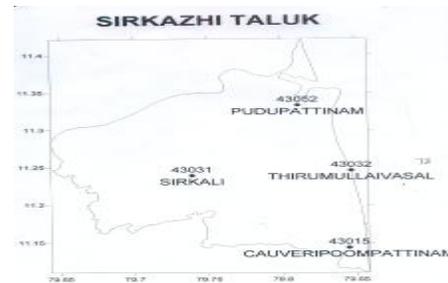
Fig. 2: Study area with sample locations (before tsunami).
