Studies on Environmental Degradation By Bani and Kardoo Landslides in Jammu and Kashmir State

Amita Fotedar and Anil Kumar Raina

Department of Environmental Sciences, Jammu University, Jammu, J&K, India

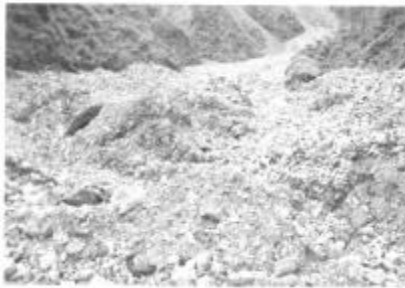
Fig. 2: Kardoo landslide with debris coming down from high cliffs.

Kardoo landslide occurs very near to muree thrust and falls exactly in folded bed of lesser Himalayas. This landslide also has one major fault, vertical in nature, covering the outcrops of Gamir formation on one hand and the murrees on the southern end, making the rocks highly unstable. The slide occurs mainly in quartzite and phyllite mix. It is 1530 m above M.S.L. and occupies a big area mostly during rainy seasons (Fig. 2). The debris in the figure is seen coming down from high cliffs. In other photograph, big boulders of quartzite are seen rolling down towards the road (Fig. 3). The latitude of the

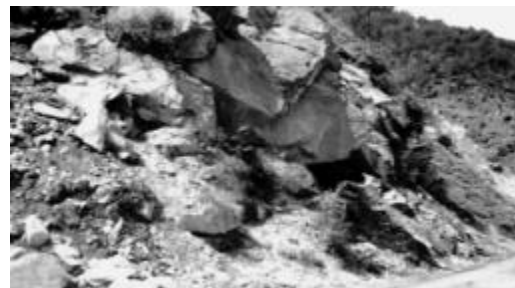
Fig. 3: Kardoo landslide showing big boulders of quartzite rolling down towards the road.

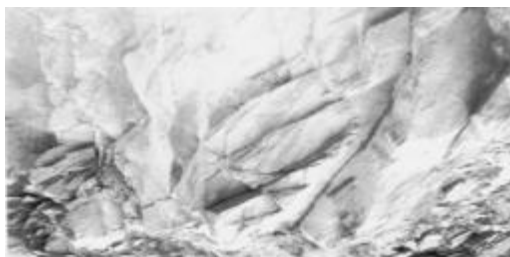
Fig. 5: Gully erosion affecting rocks at cleavage sites and breaking apart big masses of phyllitic material.

the scree material gets deposited on the roadside and blocks the road for days together during rainy season. Gully erosion affects rocks at cleavage sites finally breaking apart big masses of phyllitic material (Fig. 5). Fig. 6 shows complete view of the slide and big boulders of phyllitic material getting deposited on the roadside. During rainy season, huge scree material along with mudflows and boulders of phyllites get collected on the road, and Bani-Sarthal villages remain cut-off for days together. In Kathua district, the alteration of forest cover by people in Bani is evident by the excessive grazing of the cattle and removal of forests for fuel wood from top of the slopes making rocks barren and exposed to agents of weathering. In case of Bani landslide, slope angles vary from 20° to 60°. Geological map of the area in and around Bani is given in Fig. 7.

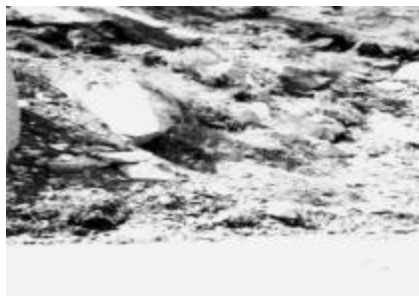
Fig. 6: Big boulders of phyllitic material getting deposited on the roadside.

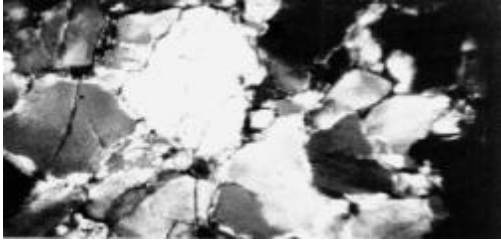
Fig. 10: Cracks present in mica flakes and quartz crystals.

Fifteen thin sections from Kardoo landslide sediments, examined under research microscope, show the imprints of crushing and bending due to strain in the minerals mainly quartz and mica, and solution cavities present in the groundmass. Besides this, there is flow texture present in the chlorites. All these points portray to the large ingress of water infiltrating through the slide area mass. Fig. 8 shows the development of numerous joints and cracks in the quartz crystals. In the centre of the photograph, the quartz and chlorite crystals occupy the solution cavity created by ingress of water. Fig. 9 shows serialization of phyllite crystals in which water has played an important role. Fig. 10 shows the cracks present in mica flakes and quartz crystals. The lines of water ingress filled later by crushed quartz crystals are seen in Fig. 11.

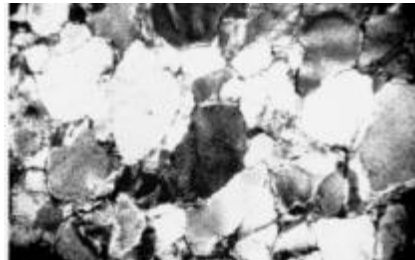
Fig. 13: Bending of mica flakes in phyllites.

Thin section petrography of Bani reveals crushing behaviour of the rocks (Fig. 12). Fig. 13 shows bending of mica flakes in phyllites. Fig. 14 portrays wiping off the lamellae of plagioclases present. Chlorite ground mass is infiltrating through the joints of the crystals resulting in the serialization of the plagioclases. Fig. 15 shows a big crystal of chlorite having developed cracks due to moving waters through the landslide mass. Thin section petrography and geochemistry reveals that the rocks at Bani landslide have been affected by water ingress, but unlike Kardoo landslide, the water infiltration is lesser in Bani area.

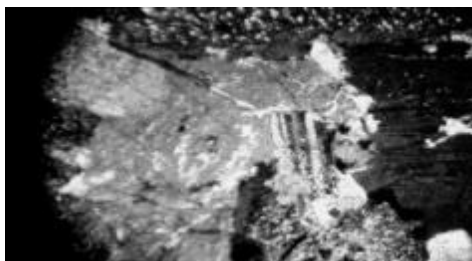
Fig. 14: Wiping off the lamellae of plagioclases.
