Abrasion and Accretion Analysis in Demak, Indonesia Coastal for Mitigation and Environmental Adaptation

A. Irsadi†, N. K. T. Martuti, M. Abdullah and L. N. Hadiyanti

ABSTRACT

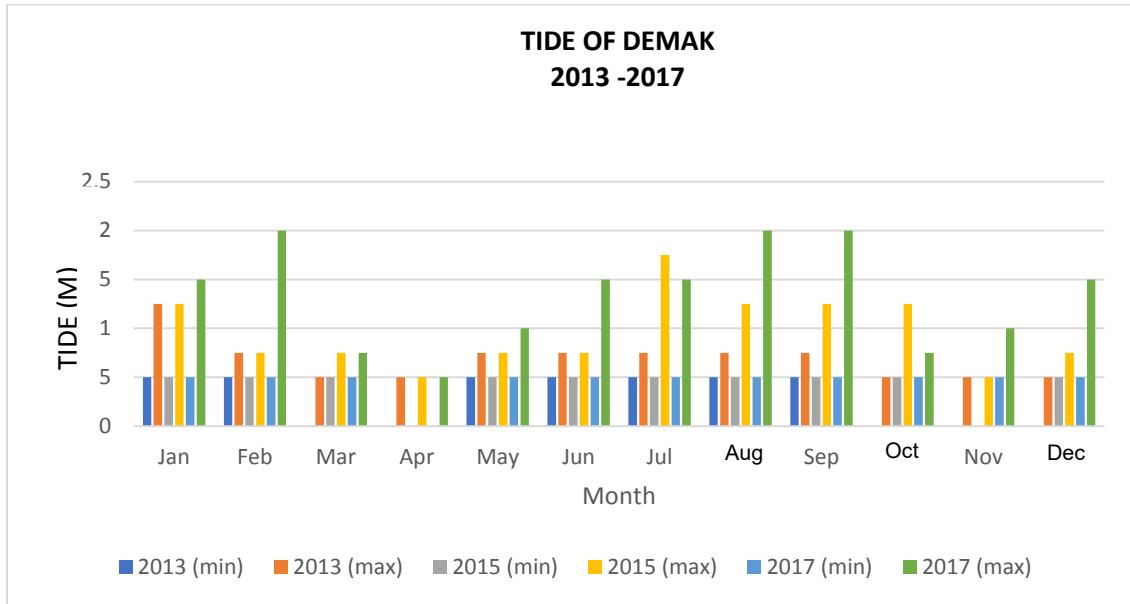
Fig. 3: The tide in Semarang and Demak in 2013-2017.

Fig. 3 shows that the wave height in the Demak area at each stage tends to increase. This makes alertness and efforts to deal with abrasion in the Sayung, Demak area. It should also be noted that the trend of increasing temperatures in the Sayung, Demak, Indonesia regions.

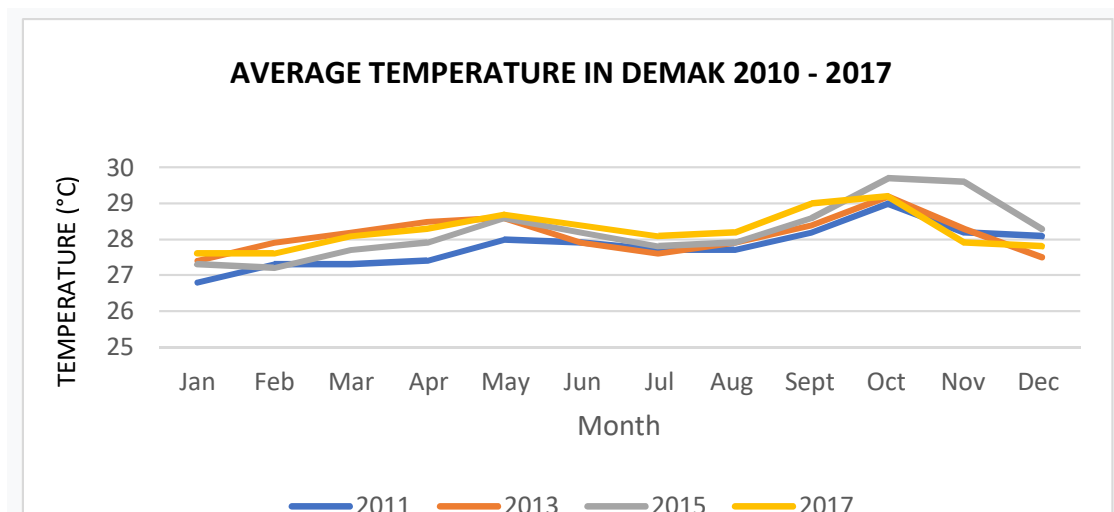
Fig. 4: The average temperature in Demak 2010-2017.

The average temperature in the Demak area has increased between particular months, as seen in Fig. 4. The fact that the state of abrasion, wave height, and temperature have all

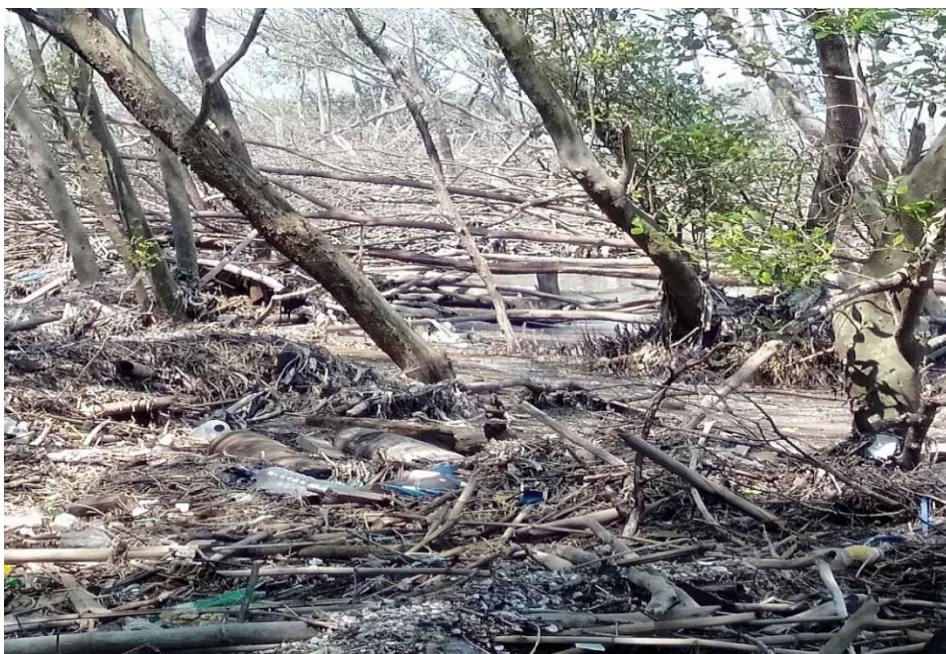
Fig. 5: Mangrove damage in Sayung coastline, Demak, due to tide.

The continuous abrasion will break the coast of Sayung, Demak, Indonesia since the ocean strongly influences the coastal ecosystem. As part of it, Mangroves will be damaged and crashed due to abrasion, as shown in Fig. 5 (Gilman et al. 2006).

Fig. 5 shows visible damage on the coast of Sayung, Demak due to wave stroke. This episode is one of the factors contributing to the destruction of mangroves in Sayung, Demak, Indonesia. Damage to mangroves disrupts mangrove inhabitants, such as birds that live in or forage in mangrove forests. Birds are disturbed by a variety of natural activities

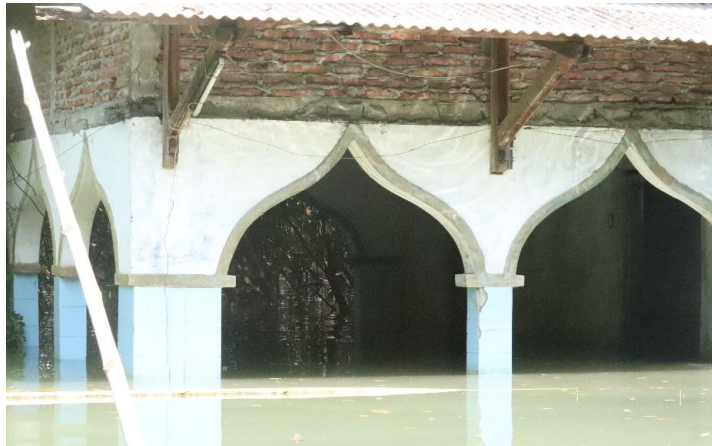
Fig. 6: Abandoned mosque submerged by flood.

Disaster tourism due to abrasion is one of the tours in Bedono Village (areas affected by abrasion so that the area is flooded with seawater and cannot be re-occupied). This tour is the location of introspection for residents who always try to protect the coastal areas from the dangers of abrasion and flooding (Fig. 6).
