General Research Paper

Studies on the Impact of Arpa River Check Dams on the Microenvironment of District Bilaspur, Chhattisgarh

S. J. A. Bhat and S. M. Geelani

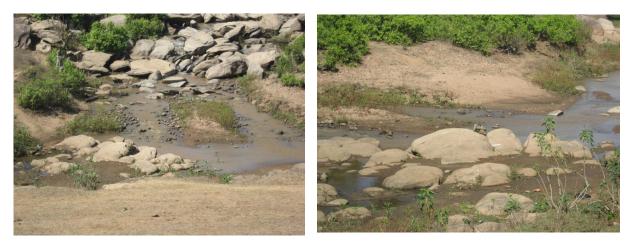
Fig.1: Origion of Arpa river at Khondari-khongsara at Pendra.

Origin and nature of Arpa river: Arpa river is originated from Khondari-Khongsara, at Pendra (tehsil) in Bilaspur

district (Fig. 1). The length of Arpa is about 147 km and average water flow is 400 m. River catchment area is 2022 sq.km. The water flows from north-west to south direction. Except rainy season, it faces scarcity of water. During rainy season its water level raises 2-3 m up and in summer season it moves 5m down (Joshi et al. 2004). The river bed is mostly sandy with a thickness of about 1.5m and few rock exposures at some places. The salient features of Arpa river are given in Table 1.

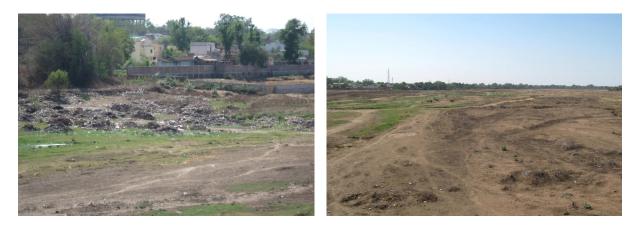
Fig. 2: Origin site of Arpa river showing its drying.

Present conditions of Arpa river: From Khondari-Khongsara to Bilaspur, the river passes through various adverse conditions. Streams originating from the Michel range which is located between the Khondari-Khongsara is the source of water of this river which flow throughout the year. Between Belgahan and Bilaspur there is no such stream which can add water to the river. Its width between Belghan to Bilapur is quite wide as compared to the availability of water. For last five years this river has been fully dependent on rain water. The main reason behinds this is the drying of its origin sites as shown in Fig. 2.

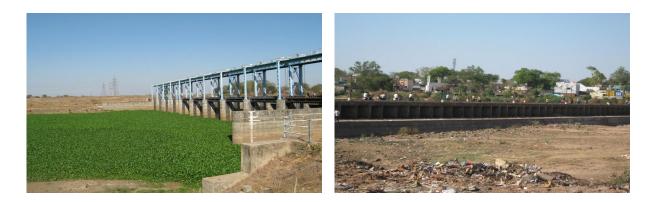
Fig. 3: Check dams (Mangla) and (Rapta) are constructed on Arpa river.

More than 10 check dams have been constructed on this river. Earlier these check dams were constructed to overcome the problem of irrigation and for human welfare (Kerr 2002). But due to the drying of its origin sites for last 5 years its water content is decreasing day by day and these check dams have become danger for the river. The maximum part of the rain water gets stored in these check dams and is used by the local people and as a result little water reaches to Bilaspur (Kerr et al. 2004). The features of two important check dams on Arpa river are presented in Fig. 3.
